# Case Brief: Successful treatment of canine wound dehiscence and infection with V.A.C.® Therapy post Tibial Plateau Leveling Osteotomy (TPLO) surgery

South Texas Veterinary Specialists, San Antonio, Texas  
Sarah Israel, DVM, DACVS; Shelly Hickman, CVT

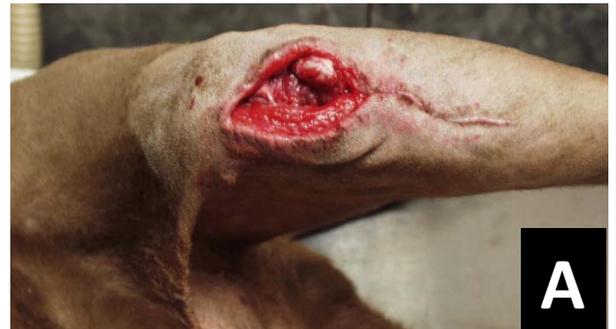
## Post Debridement

Skin staples were removed from the proximal portion of the incision and the wound was opened. The patient was given morphine prior to the initial debridement as well as post-operatively, along with tramadol for pain alleviation. Image A shows the wound post debridement. The wound was flushed, cultured, and amoxicillin/clavulanic acid was prescribed for the initial infection control prior to the results of the culture. The culture returned a positive result for *Pseudomonas aeruginosa*, which confirmed infection of the wound. Based on the culture and sensitivity it was decided to switch the patient to enrofloxacin for 10 days to treat the infection. V.A.C.® Therapy was chosen to help

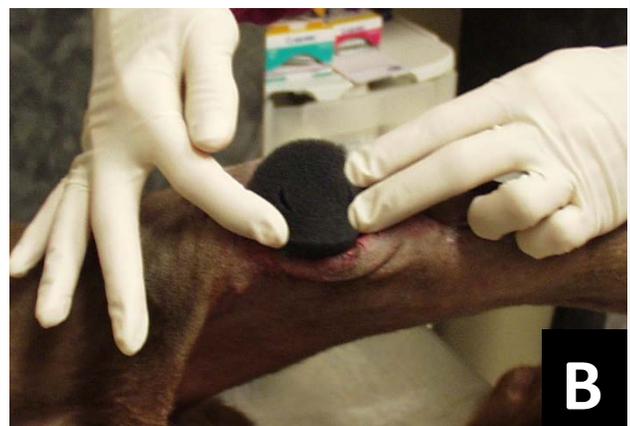
## Placement of V.A.C.® Granufoam™ Dressing

The wound periphery was prepared by removing the hair, drying, and applying a medical adhesive spray. V.A.C.® GranuFoam™ Dressing was then trimmed to the wound size and placed, ensuring that it did not come in contact with intact skin (Image B). V.A.C.® Drape (Image C) and the T.R.A.C.™ Pad were then applied over the wound. V.A.C.® Therapy was delivered for 48 hours at -125 mmHg, with no dressing changes needed.

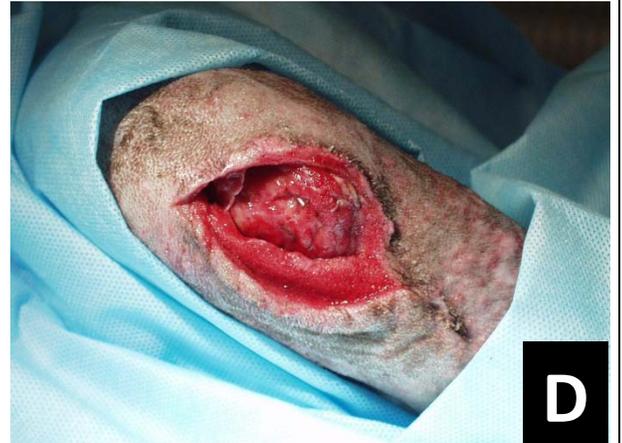
### **Post V.A.C.® Therapy**

Upon therapy removal, tissues appeared healthy and had a healthy bed of granulation tissue (Image D). The fascia was closed with 2-0 PDS in a simple interrupted pattern. The skin was closed with 3-0 monocryl in a simple continuous pattern, and skin staples were placed. The patient continued to heal without any further reoccurrences of infection or dehiscence. The incision site looked great during the follow up visit to remove the staples.
